# IR Cameras and Building Insulation Performance

FLIR Systems, Inc

## **Infrared Inspection of Building Envelopes - 2009**

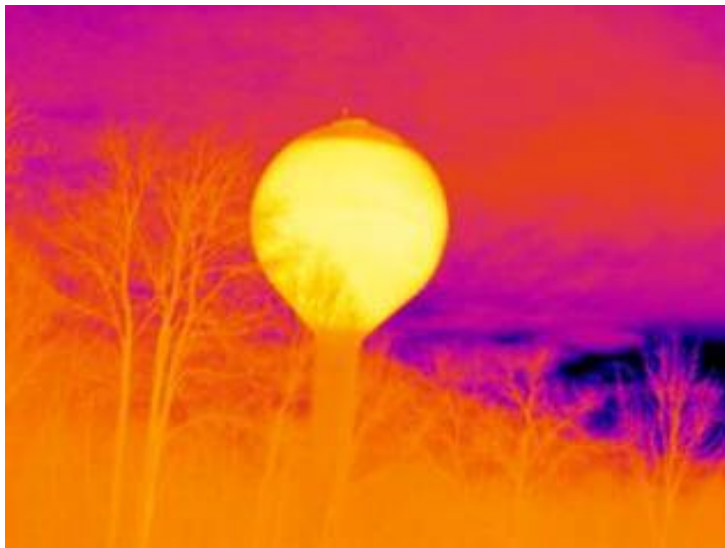
Small targets

Large targets

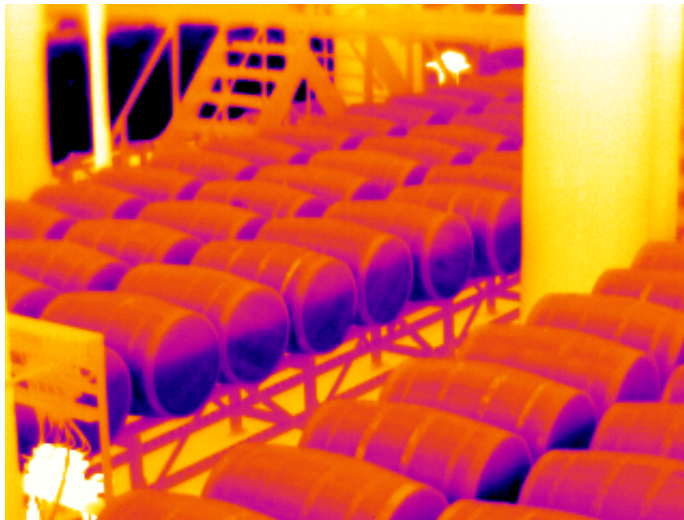
Wood Barrels -  
High Emissivity &  
Low Reflectivity

Shiny Metal -  
High Reflectivity  
& Low Emissivity

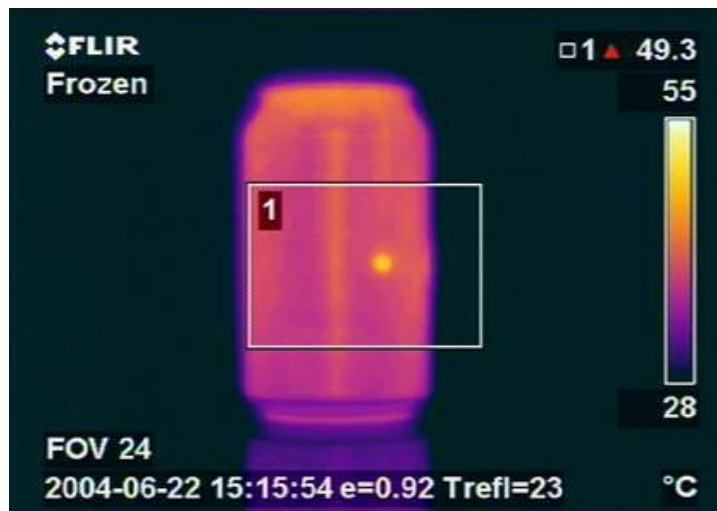
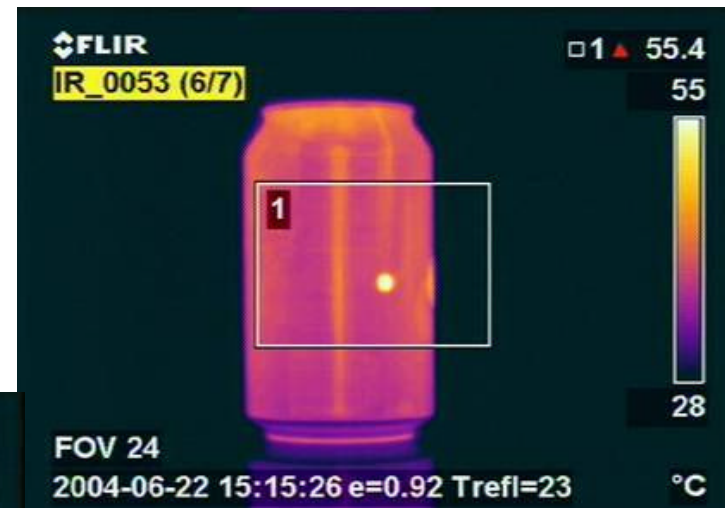
Focused =  
Accurate

Unfocused =  
Inaccurate

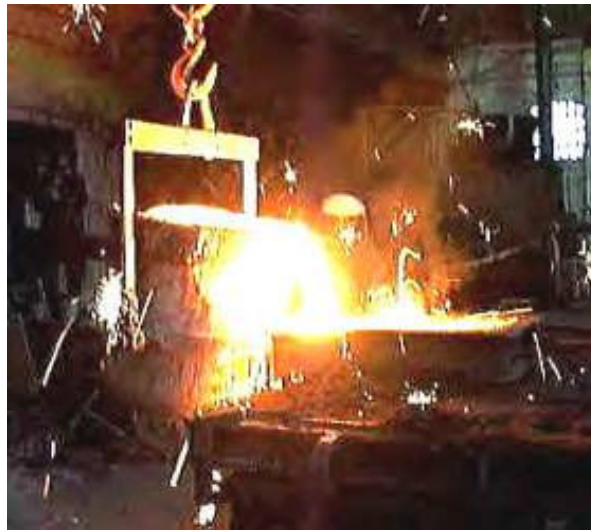
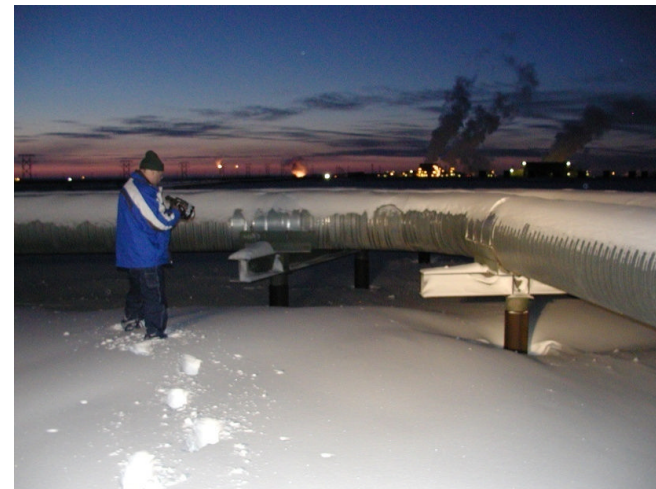
From this

To this

Camera should remain accurate through it's entire operating range

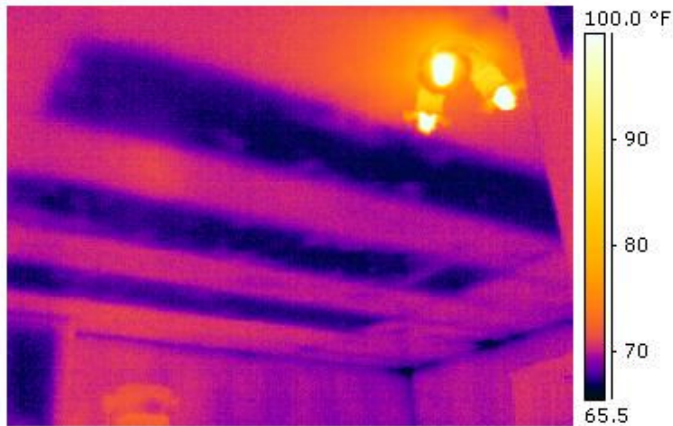
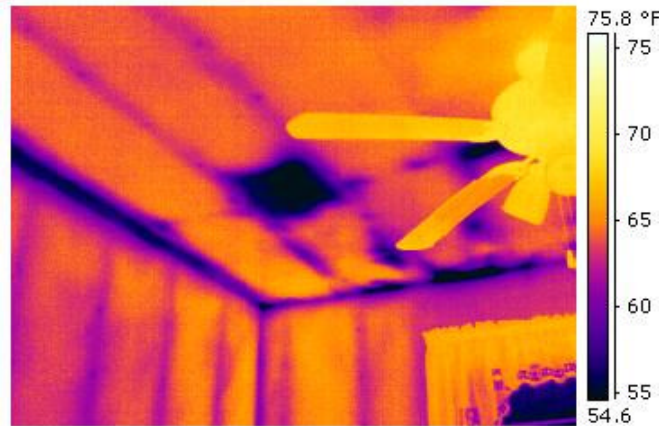
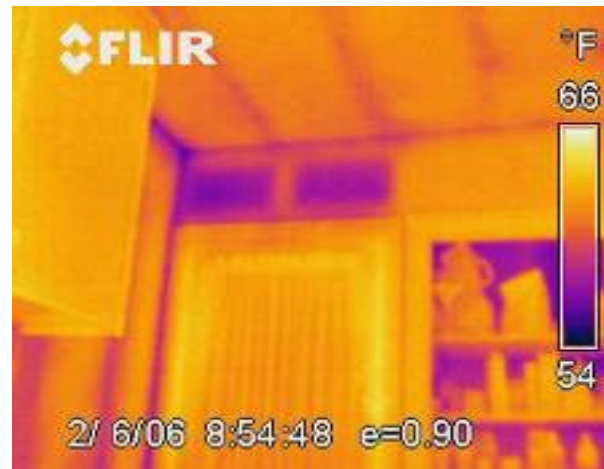
# Missing Insulation Is Evident With The IR Camera

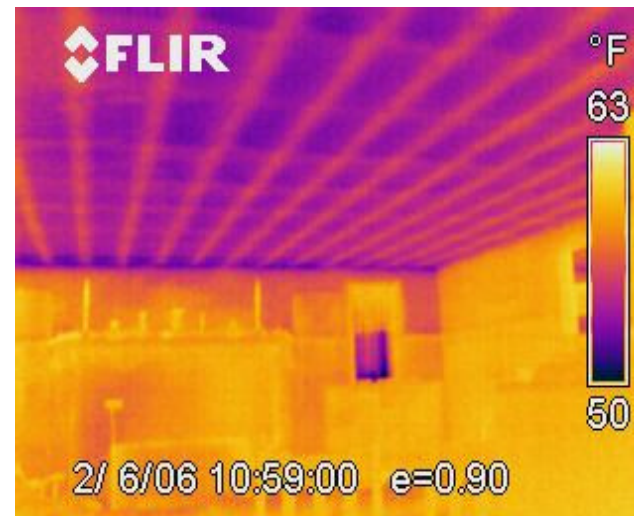
# No Insulation In Attic
