## Challenges and Opportunities of Energy Star in Modular Home Construction: Lessons from the Field

Factory Built Housing Center  
Pennsylvania College of Technology

### RESNET Conference

February 18, 2009

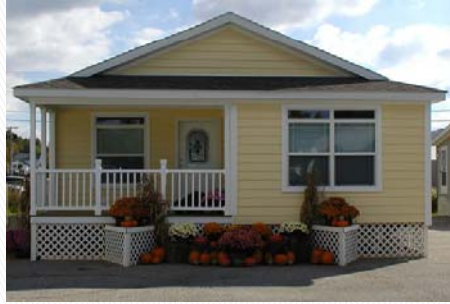
Manufactured (HUD)

- ▶ Manufactured or HUD code homes are built to a different federal code
- ▶ Structures include integrated metal frames with, hitches, wheels and axles (Often removed on site)
- ▶ Have separate programs and options for Energy Star Certified Homes
- ▶ May be placed on permanent foundation or moved from site to site
- ▶ Much confusion in public eye and even within stakeholders of industry
- ▶ Some traditionally manufactured housing plants now building some modular “qualified” products based on their HUD products adding additional confusion

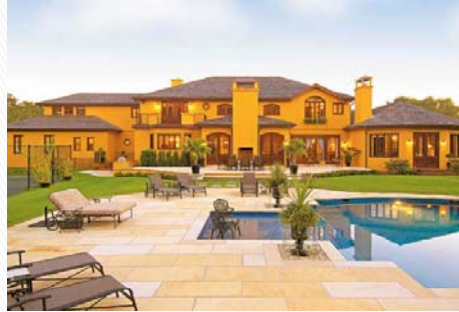
Modular (IRC)

- ▶ Built to same IRC codes as traditional site construction
- ▶ Some States may have some specific code exceptions for modulars; i.e. stair geometry, third party inspections and approvals, liability of on site code officials
- ▶ Challenges on site include proper building science applications, subcontractors and knowledgeable builders
- ▶ Set crew, builder, & subcontractor disturbance of the thermal envelope and work completed in plant
- ▶ Dealing with Cape Cod and 2 Story designs (i.e. separate ceiling and floor systems)

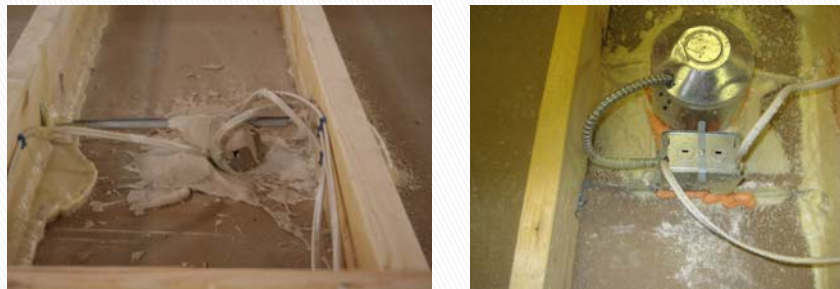
Recessed Lighting...

Always a challenge...

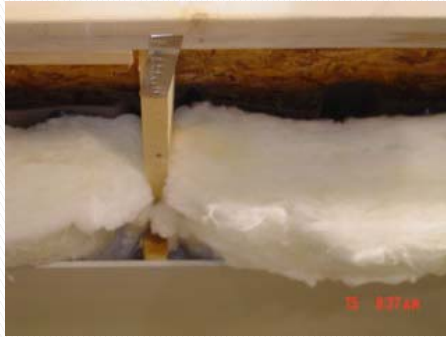
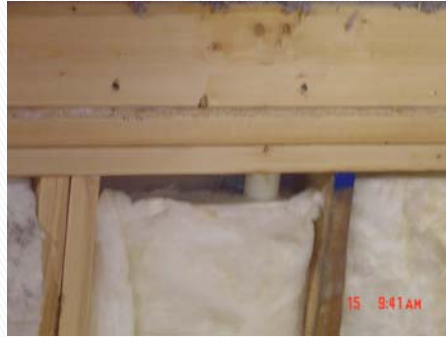
Insulation Installation...

Always a challenge...

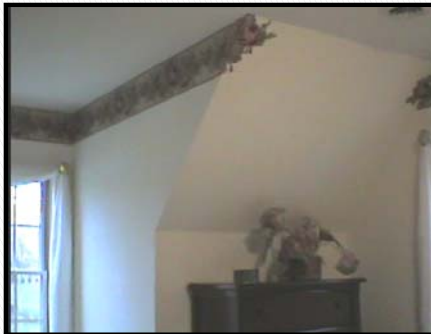
Scan showing the results of that improper install...

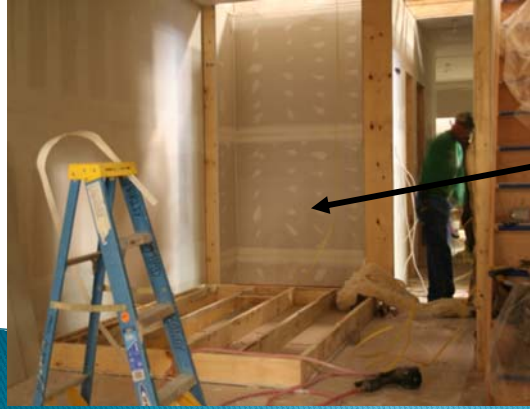
## Large built in chaseways to accommodate mechanical systems

Contractor should air seal these chase ways in the attic as well as in the basement

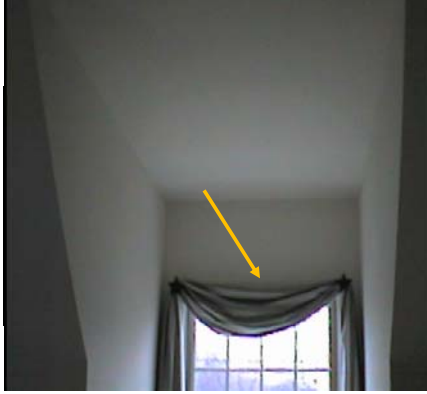
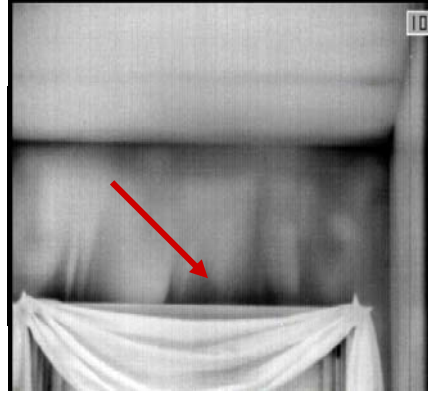
Air infiltration at drywall & window molding

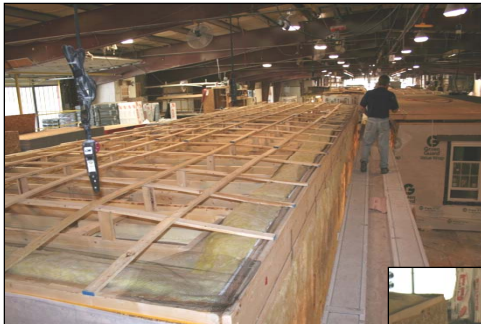
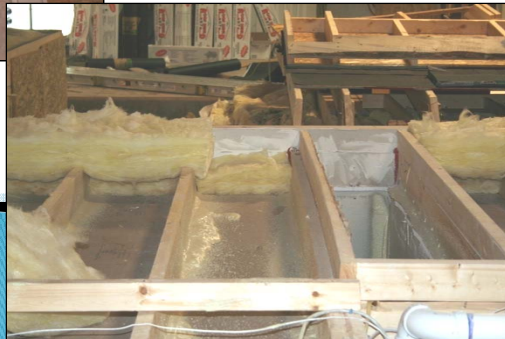
## Insulation Around Perimeter Band Joist

Common industry practice to put 3' – 4' of batt insulation from perimeter towards center of unit

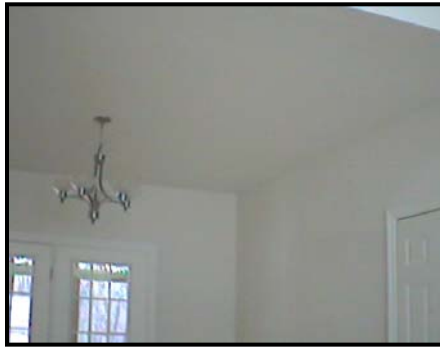
Insulation was installed on the exterior band joist across the ceiling three feet. This did not stop or reduce the amount of air flow across the ceiling to the marriage wall.

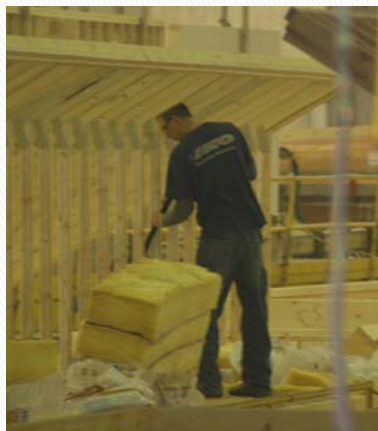
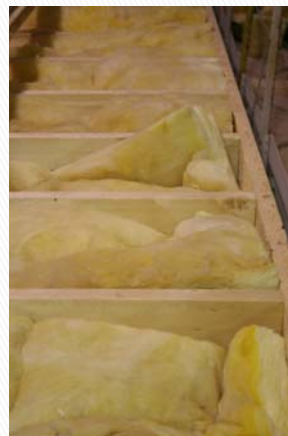
## Compressed Insulation

Similar to site construction...Insulation installation is one of the least popular tasks often left to the newest hire or least skilled labor.

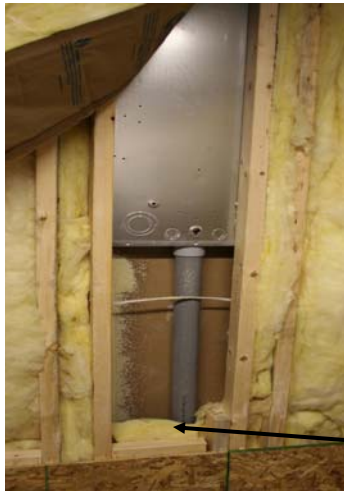
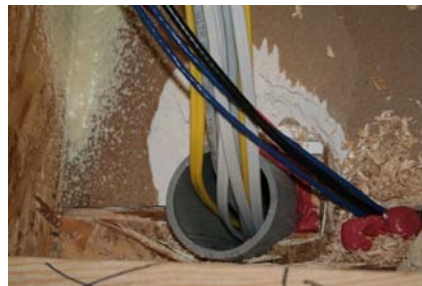
Wiring chase ways should be sealed.

Compressed insulation

Electrical panel located on exterior wall. Allows air movement and moisture movement as well as limits the amount of insulation in the wall cavity.

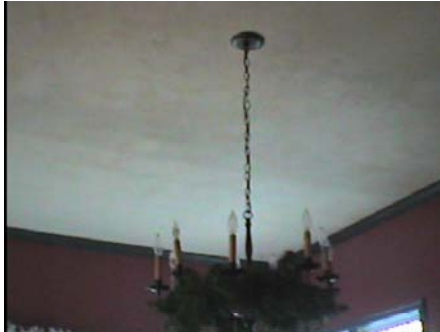
Bump out section where multiple modules connect. Cold air at center support beam.

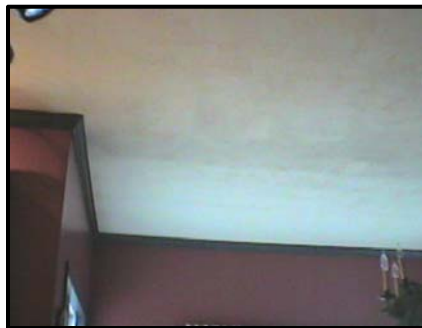
This dark area is where the modular first floor bump out was attached to the first floor rear section. Air is infiltrating at the connection of these two boxes which indicates a lack of proper sealing between units. (L)

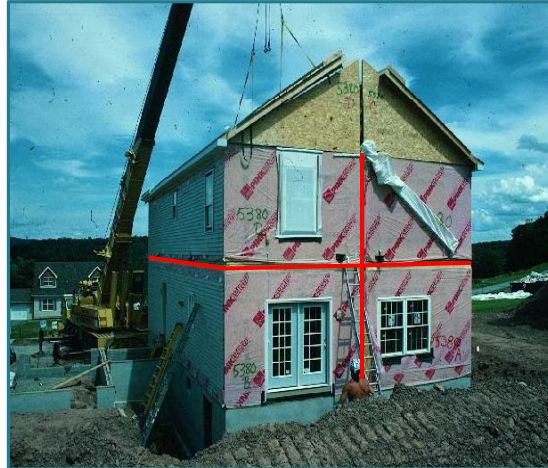
- Fiberglass insulation is not enough to properly seal
- Air seal the perimeter between floors before siding is installed.
- Seal all gaps on the marriage wall at archways and door openings before installing trim.

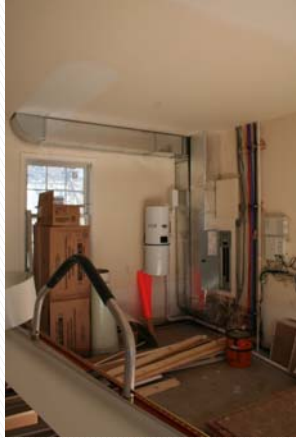
Connection between basement, apartment, bonus room, and attic...

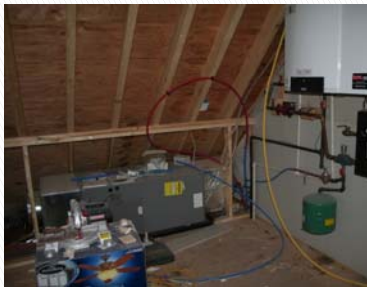
Air handler located in unconditioned attic...disconnected ductwork
