A Rater's perspective from the field

Thomas H. Marston, February 21, 2007

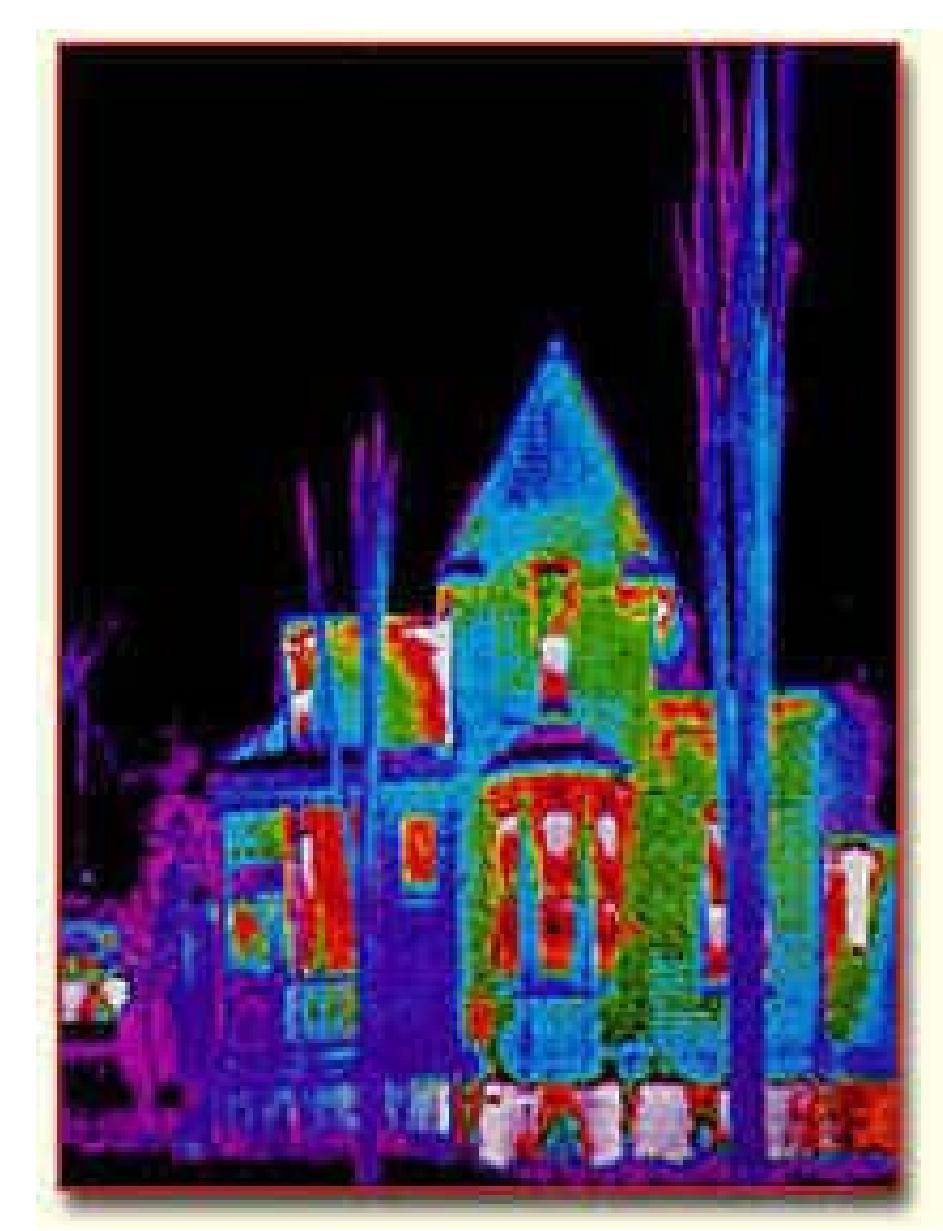
The checklist looks at the thermal envelope - the place where air sealing and insulation meet. Each of the items addresses a potential problem

If you understand this slide, you understand the checklist. We'll come back to this Shower/tub at exterior wall Exterior walls have been enclosed on all six sides and exterior walls have been fully insulated
